AAIB Bulletin S1/2024

SPECIAL

Serious Incident

Aircraft Type and Registration:	Boeing 737-8K5, G-FDZS	
No & Type of Engines:	2 CFM56-7B27/3 turbofan engines	
Year of Manufacture:	2009 (Serial no: 35147)	
Date & Time (UTC):	4 March 2024 at 1104 hrs	
Location:	On takeoff from Bristol Airport	
Type of Flight:	Commercial Air Transport (Passenger)	
Persons on Board:	Crew - 6	Passengers - 163
Injuries:	Crew - None	Passengers - None
Nature of Damage:	None reported	
Commander's Licence:	Airline Transport Pilot's Licence	
Commander's Age:	47 years	
Commander's Flying Experience:	14,500 hours (of which 4,500 were on type) Last 90 days - 220 hours Last 28 days - 81 hours	
Information Source:	AAIB Field Investigation

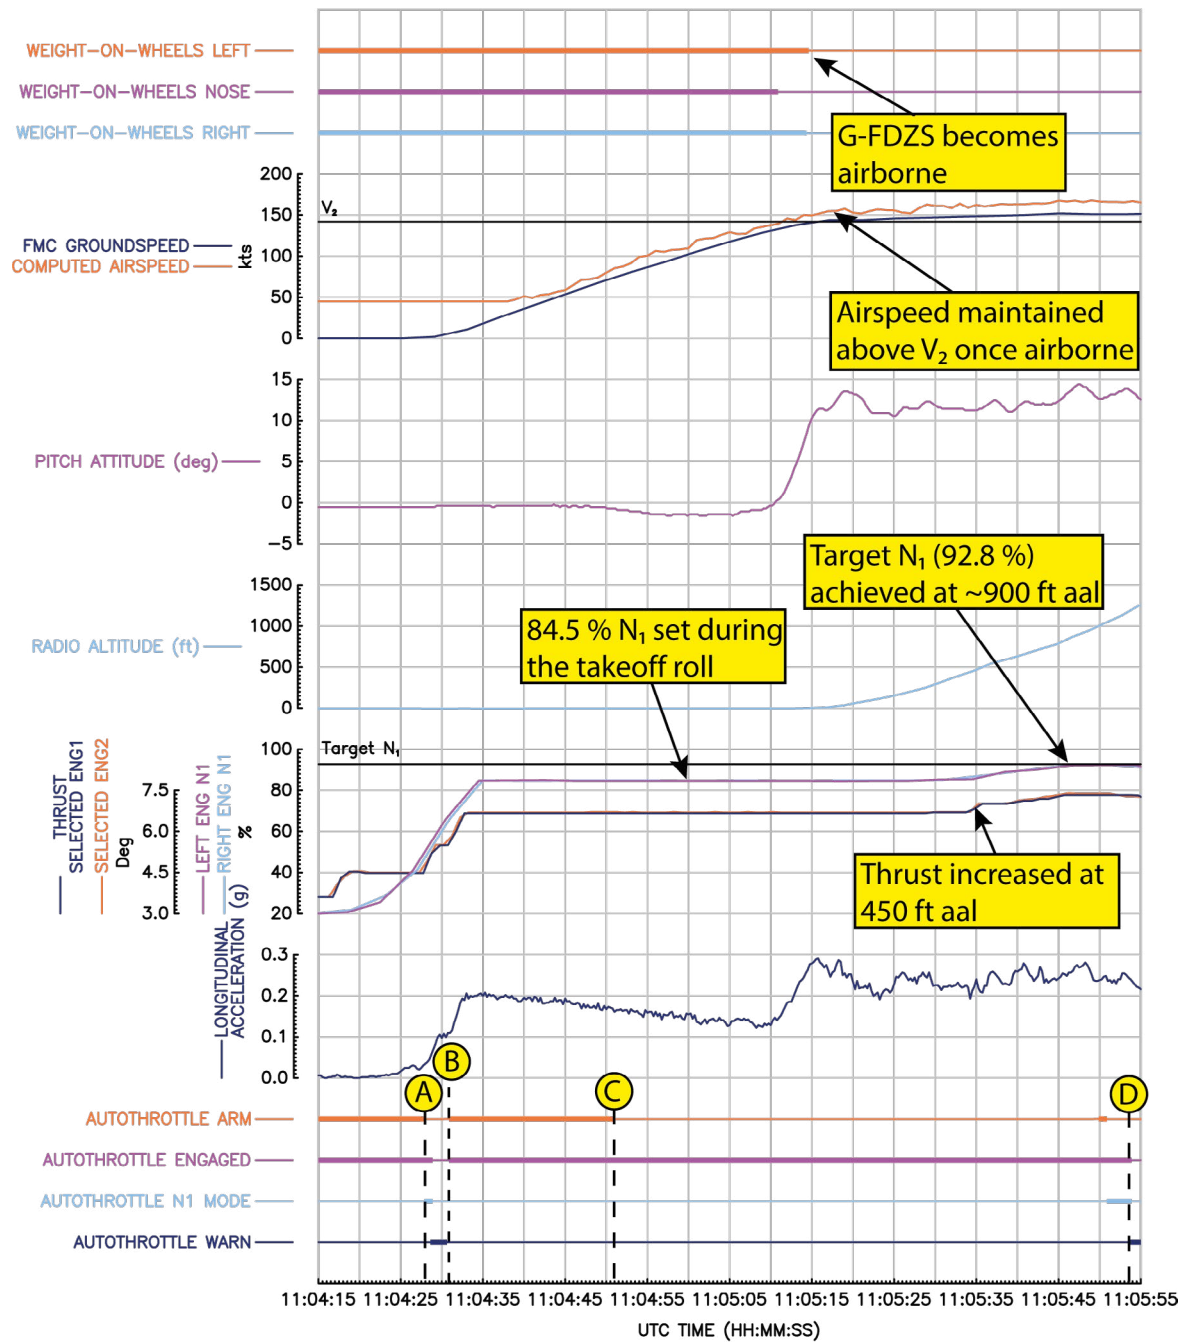
Figure 1
FDR data for the takeoff

- (A) A/T transitions from ARM to N1 mode on TOGA selection, disconnects almost immediately with a warning
- (B) A/T re-armed within five seconds but no active mode selected
- (C) A/T transitions to ARM HOLD mode, as per design, at 84 kt
- (D) A/T transitions from ARM to N1 mode, but disconnects with a warning almost immediately (2nd uncommanded disconnect)

The data shows that 84.5% N_1 was set for the takeoff instead of 92.8% N_1 and, although the thrust setting was increased from 450 ft aal, the required takeoff thrust setting was not attained until passing approximately 900 ft aal. As a result, G-FDZS became airborne 260 m from the end of Runway 09 and the runway end was overflowed at a height of approximately 10 ft. Further, as the correct thrust setting was not set until passing approximately 900 ft aal, the A38 road, adjacent to the boundary of Bristol Airport, was overflowed at less than 100 ft.

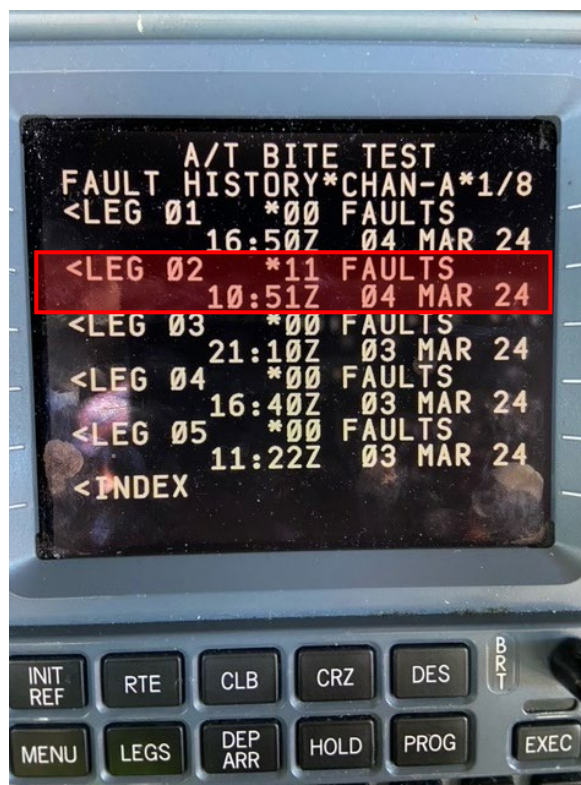
Figure 2

The MCDU allows maintenance personnel to interrogate the health of several aircraft subsystems, including the A/T, and to investigate any logged faults. The fault history for the A/T, (Figure 2), shows that 11 faults were logged for the incident flight to Las Palmas - LEG 02 - but no faults were logged on the return flight to the UK, or on the preceding day.

A/T fault history for the incident flight and the preceding day

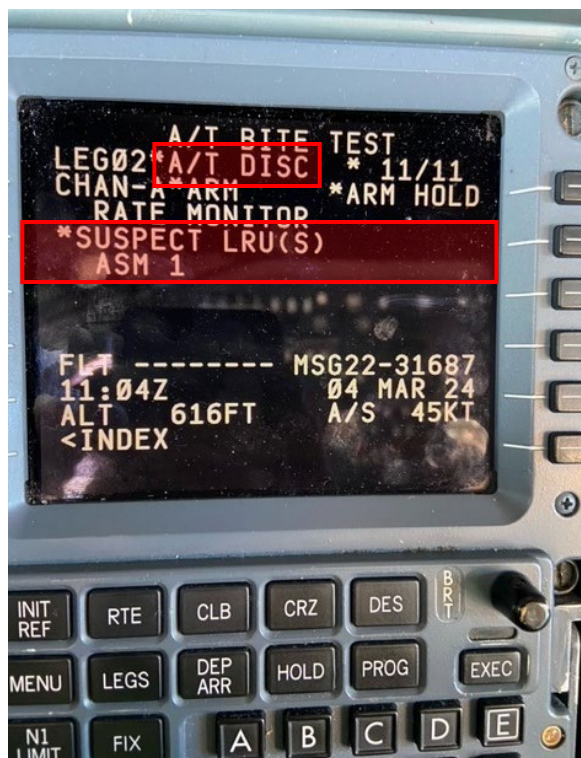
Figure 3

Detailed fault record for the initial uncommanded A/T disconnection, showing the suspected cause as ASM 1

The fault record indicates the suspected cause of the uncommanded A/T disconnection as ASM 1, the A/T servo motor for the number 1 engine throttle lever. A further four uncommanded A/T disconnections occurred during the flight to Las Palmas, two during the initial climb to altitude and two during the cruise. A series of other fault messages were logged, after the initial A/T disconnection, as G-FDZS accelerated for takeoff. These were generated passing 90 kt airspeed and all related to the mis-set thrust, indicating that the correct takeoff thrust had not yet been set.

A newer model of the ASM is more robust to the power quality issues associated with power on and power transfer events and the manufacturer recommends that any operators of the 737NG who are affected by these disconnects should retrofit their aircraft with the newer model of ASM and associated Flight Control Computer software. The manufacturer released a Fleet Team Digest in October 2021 detailing the issue and the available service bulletin (SB) for replacement. At the time of this event G-FDZS was fitted with the earlier model of ASMs.

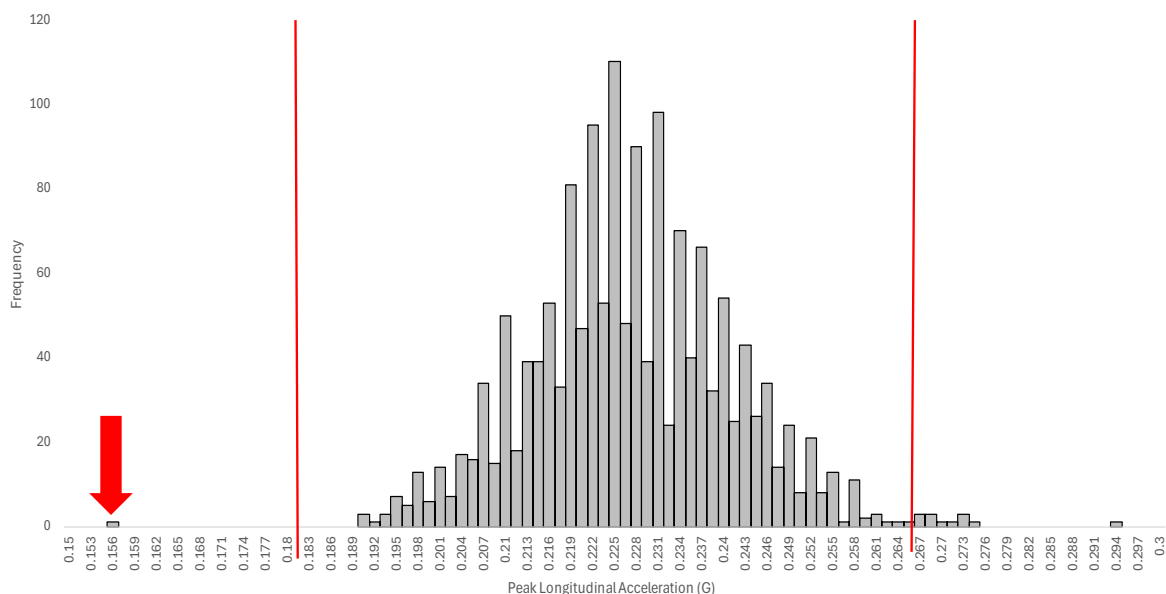
Figure 4

Although this event was reported, the operator conducted a retrospective analysis using a simple statistical measure of other 737 takeoffs from Bristol and produced the plot shown in Figure 4. The X-axis represents the peak longitudinal acceleration at around 80 kt groundspeed and the Y-axis the number of takeoffs that are represented by each bar. The incident takeoff is shown by the red arrow in Figure 4, far to the left of the bulk of the data, whereas for a normal distribution of data 99.7% of all takeoffs would be expected to lie within the region marked by the two vertical red lines.

Histogram of 737 takeoffs at Bristol, showing the normal spread of peak accelerations and the incident takeoff
